The Turning Point is a monthly newsletter covering topics from various industries and sectors. The Turning Point will respond to your inquiries and inform you of current services and updates regarding

Raising the Standard Consulting Inc.

Often overlooked Hazard of an Angle Grinder

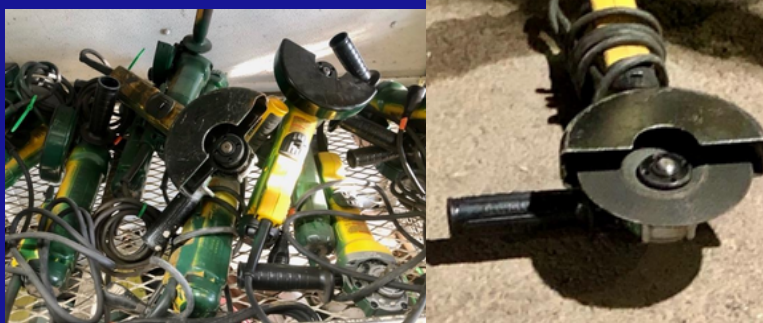
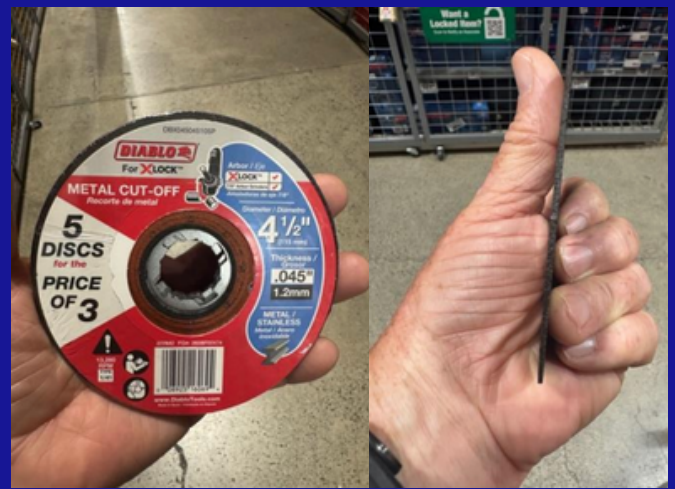
Type 1 Guard and disc

Cutting wheels require Type 1 Guards. A Type 1 guard must be used with Type 1 wheels.

The Guard must encapsulate the opposite side of the cutting wheel, 180 degrees across the perpendicular center line covering both sides. Type 27 grinding wheel guards which only cover one side of the wheel are not acceptable. In the event of a catastrophic wheel failure the shrapnel will be contained in the guard. This standard has greatly reduced injuries. Guard Type and Sizes Must match wheel specifications.

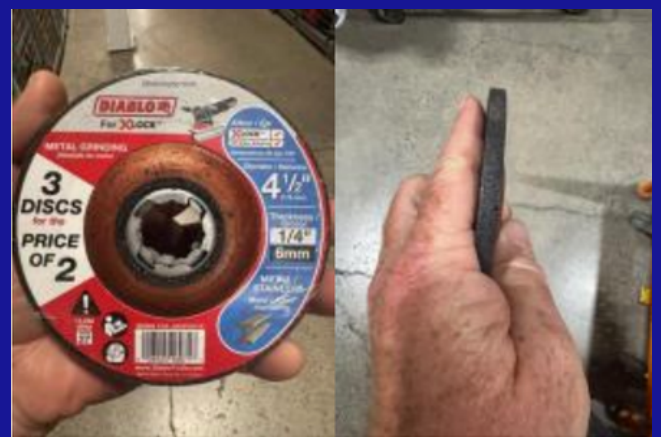
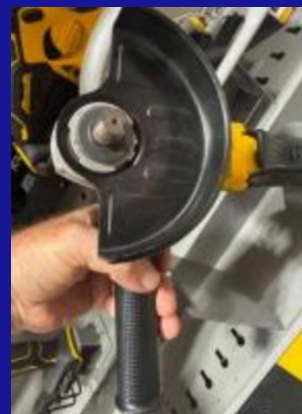
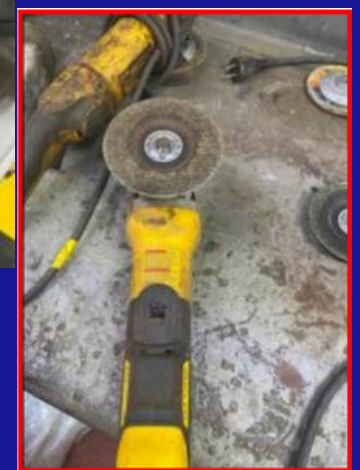
Type 27 Guard and disc

This grinder that I took a picture of (above) is extremely dangerous – a cutting disc, no handle on it for control, no Type 1 guard

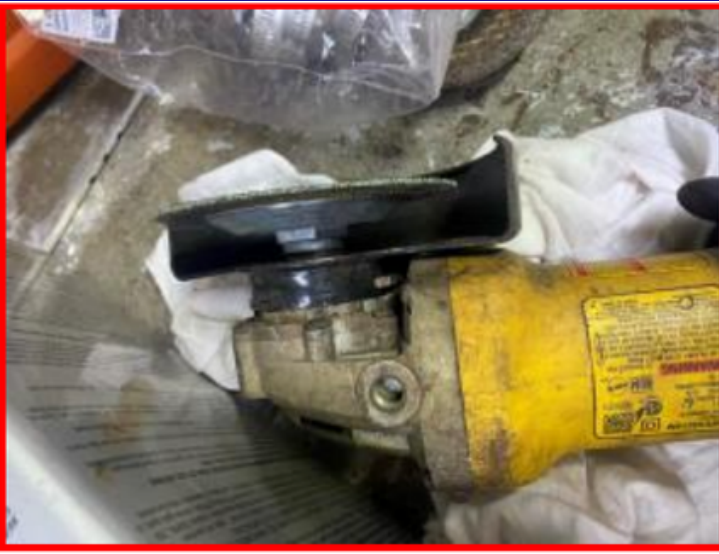
Type 1 cutting disc, but with an open face Type 27 guard that will NOT protect one from debris if the cutting disc brakes, there is no handle in place (also not in use, but make sure it is when needed)

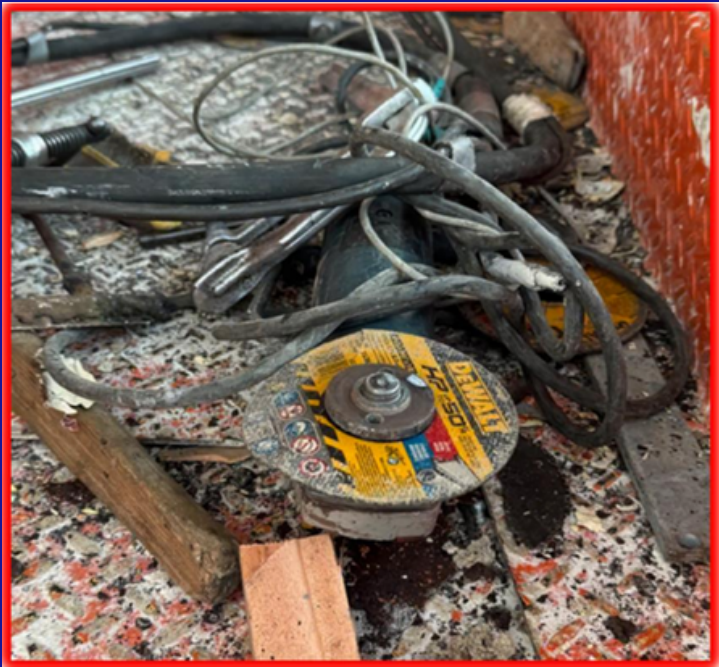
I observed this grinder in the same circumstance as described above, but with a crack in the cutting disc that has no guard at all – very dangerous. All items shown were corrected. I advise reading how to store discs too, from the manufacturer.
